AFRL-PR-WP-TR-1998-2110

**THIN DENSE CHROME BEARING
INSERTION PROGRAM
Pyrowear 675 and Cronidur Wear Testing**

GE Aircraft Engines
Advanced Engineering Programs Department
One Neumann Way
Cincinnati, Ohio 45215-6301

OCTOBER 1998

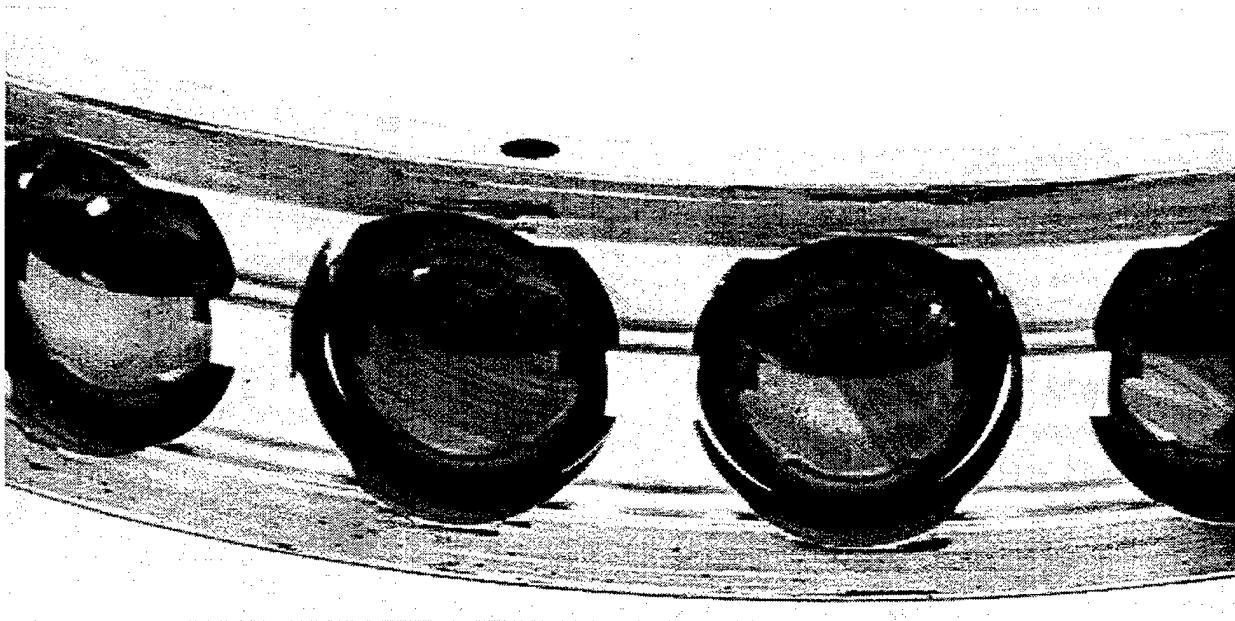
Figure 3. Cronidur 30 "Purebred" Cage and Ball Midtest Wear

Both bearings showed similar evidence of wear initiation. The balls had scratches, and some could be felt with a 0.030-inch radius scribe. The cage rail outer surfaces had circumferential scratches and local dark streaks. The cage pockets had aluminum oxide imbedded in the silver. The outer raceway curvatures had some pitting and denting on the puller groove side (the loaded side). The outer race shoulders showed some circumferential polishing. The inner raceway also had pitting and denting on the loaded half. Figures 3 and 4 show the bearings at this midtest point.

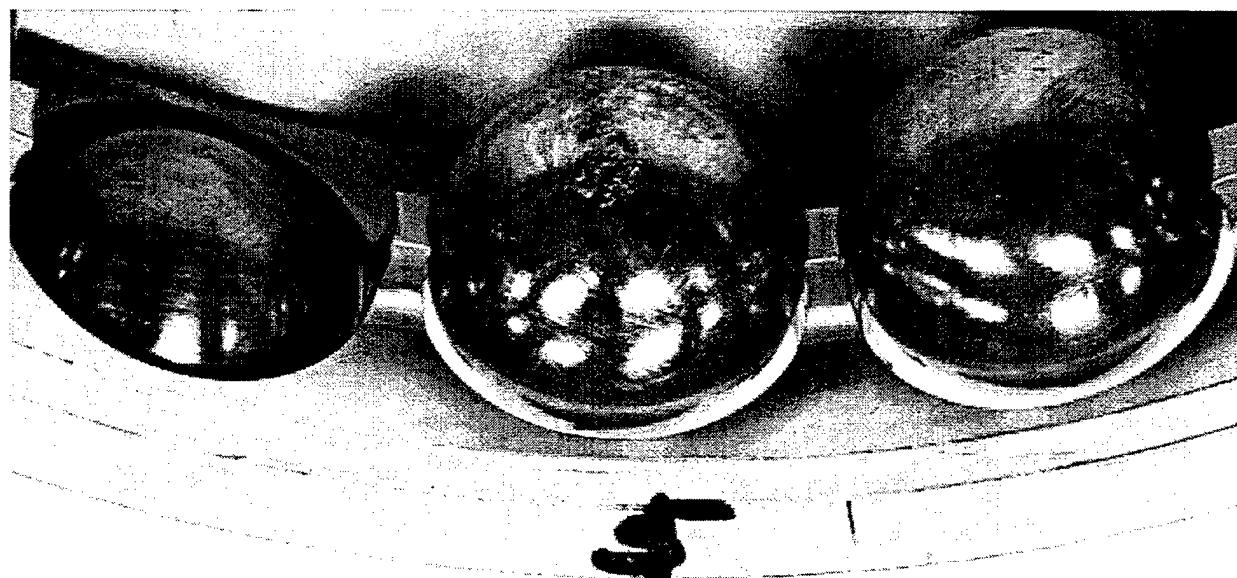
Figure 5. Cronidur 30 “Purebred” (S/N FCAA7068) Ball Ellipsoidal Wear

At teardown, the condition of the two bearings was reviewed. Several balls in one bearing, S/N FCAA7068, were severely worn—the worst ball being ellipsoid in shape. Table 2 lists ball diameter measurements. A few balls had debris denting. The second bearing, S/N FCAA7069, did not experience this severe wear but did have scratches on the balls. The cage rail outer surfaces had local dark streaks. The outer race of both bearings had some wear on the cage guiding shoulders. The outer race shoulders were measured before and after the test to reveal a radial wear depth of 0.001 inch. The loaded half of the inner race had fine pitting and denting. The raceway-to-shoulder corner appears distorted and raised. Figures 5 through 14 show the posttest “purebred” bearings.

Ball No.	Diameter, in			Radial Wear Depth, in
	Pretest	Posttest, Major	PostTest, Minor	
1	0.875	0.869	0.784	0.0455
2	0.875	0.866	0.861	0.0070
3	0.875	0.868	0.842	0.0165
4	0.875	0.869	0.864	0.0055
5	0.875	0.868	0.865	0.0050

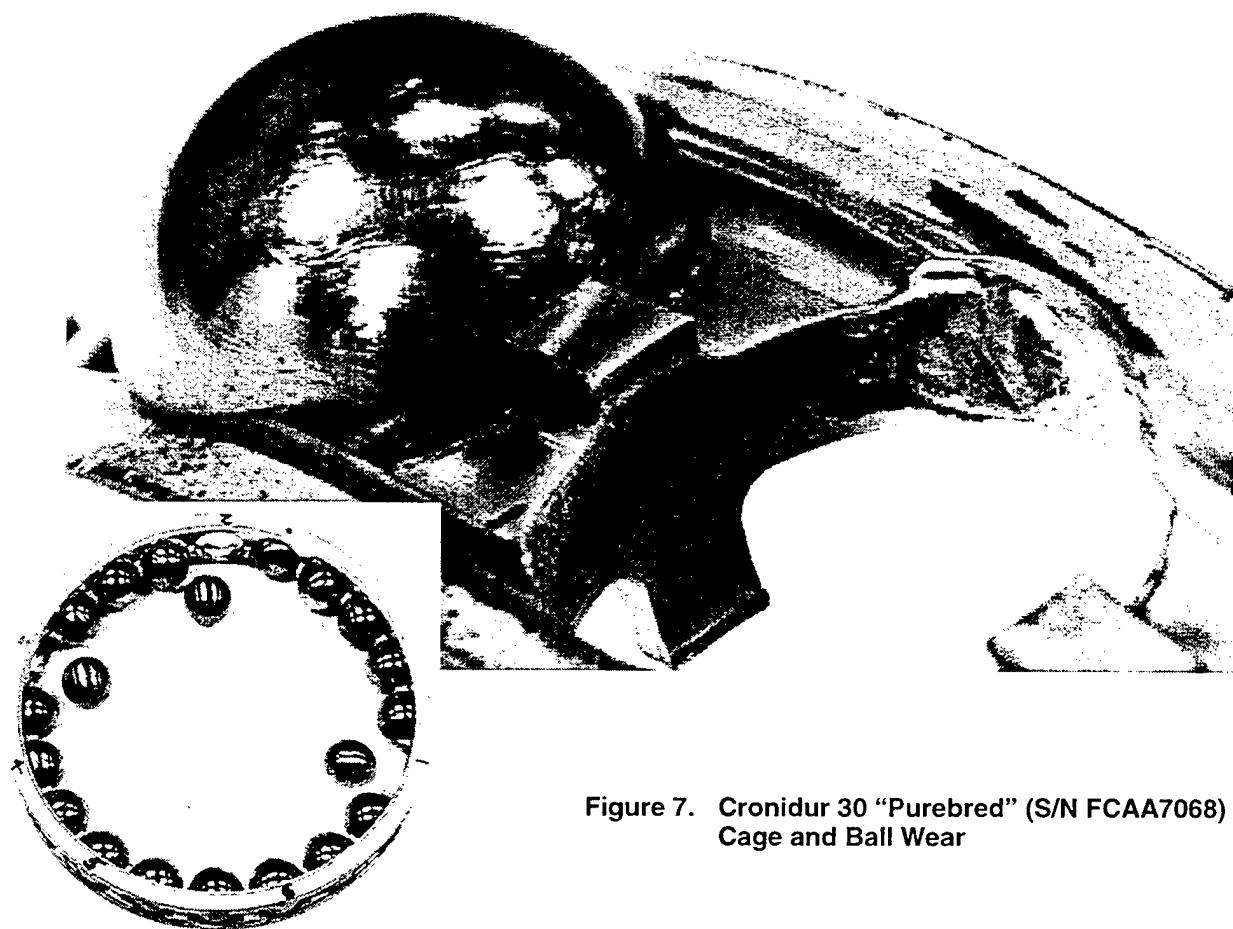
**Figure 7. Cronidur 30 "Purebred" (S/N FCAA7068)
Cage and Ball Wear**

Both bearings had shoulder wear to a depth of 0.001 inch on the outer race shoulders, and both had the local dark streaks on the cage rail outer surfaces. The excessive damage to the balls was a concern. Both bearings were subjected to material evaluation to further examine the microstructure. The wear characteristic of the Cronidur 30 “purebred” bearing was deemed unacceptable.

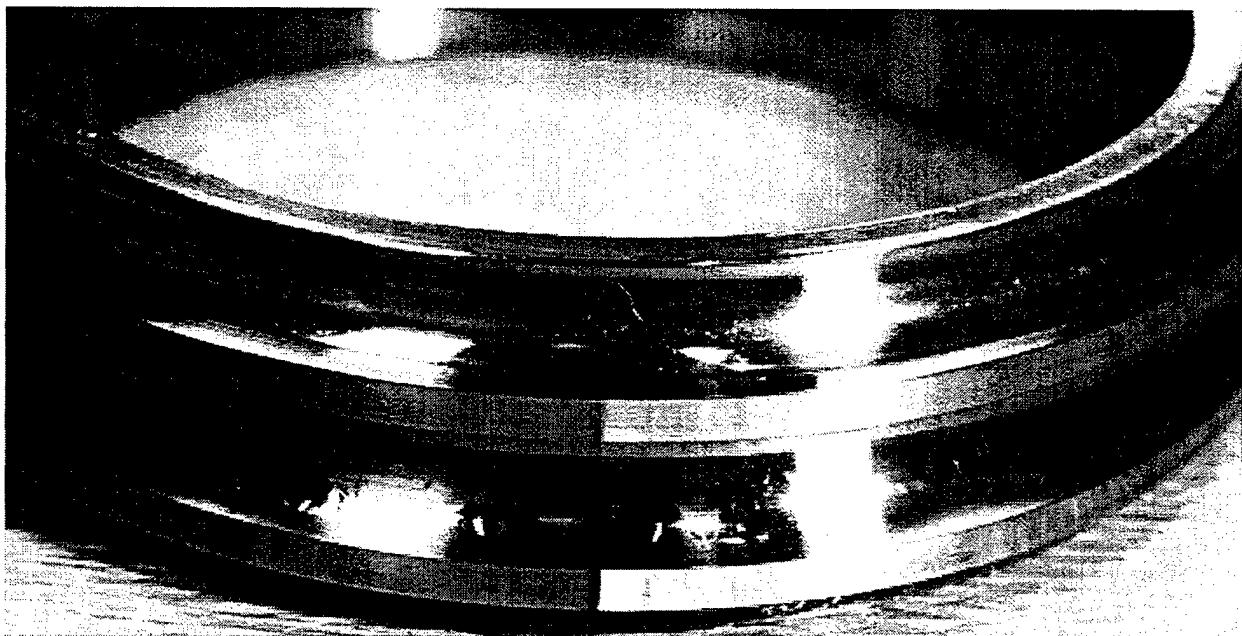
Figure 15. Cronidur 30 "Hybrid" Inner Race Shoulder Wear

Both bearings had shoulder wear as indicated by light polishing and fine scratches on the outer race shoulders and local dark streaks on the cage rail outer surfaces. Both bearings underwent material evaluation to further examine the microstructure. The wear characteristic of the Cronidur 30 “hybrid” bearing was deemed unacceptable.

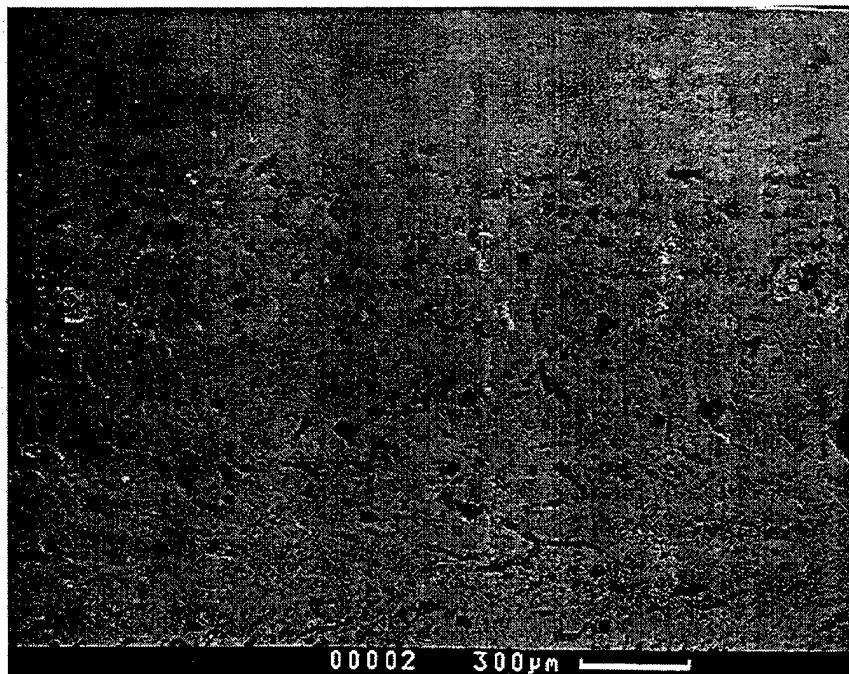
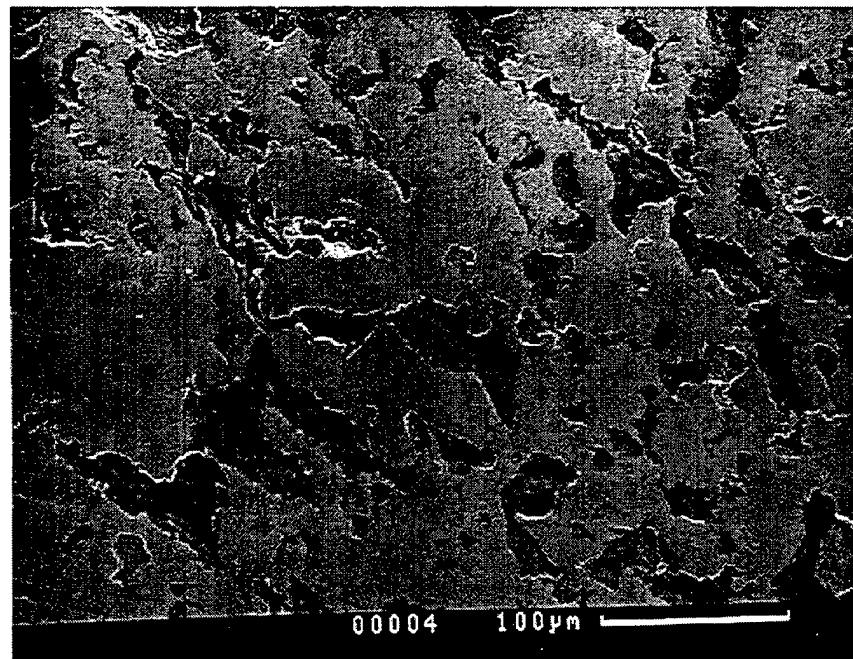
Figure 16. Cronidur 30 "Hybrid" Inner Raceway Microspalling (Page 1 of 3)

At teardown, the condition of the two bearings was reviewed. On the inner raceway, they exhibited microspalling on the loaded half. The damage was in a narrow band, about 0.10-inch wide, positioned about the middle of the raceway, and was relatively shallow. The microspalling on one bearing, S/N FCAB0971, was continuous while the second bearing, S/N FCAB0972, exhibited intermittent microspalling. Microspalling was not present on the outer race curvature of either bearing, but both had a wide shiny band and some fine pitting toward the loaded portion. The outer race cage-riding shoulders had light polishing and fine scratches. The cage rail outer surfaces had local dark streaks, and the balls had light circular scuffing. Figures 15 through 18 show the after-test conditions of the Cronidur 30 “hybrid” bearings.

Microspalling

Surface dents from test
contamination

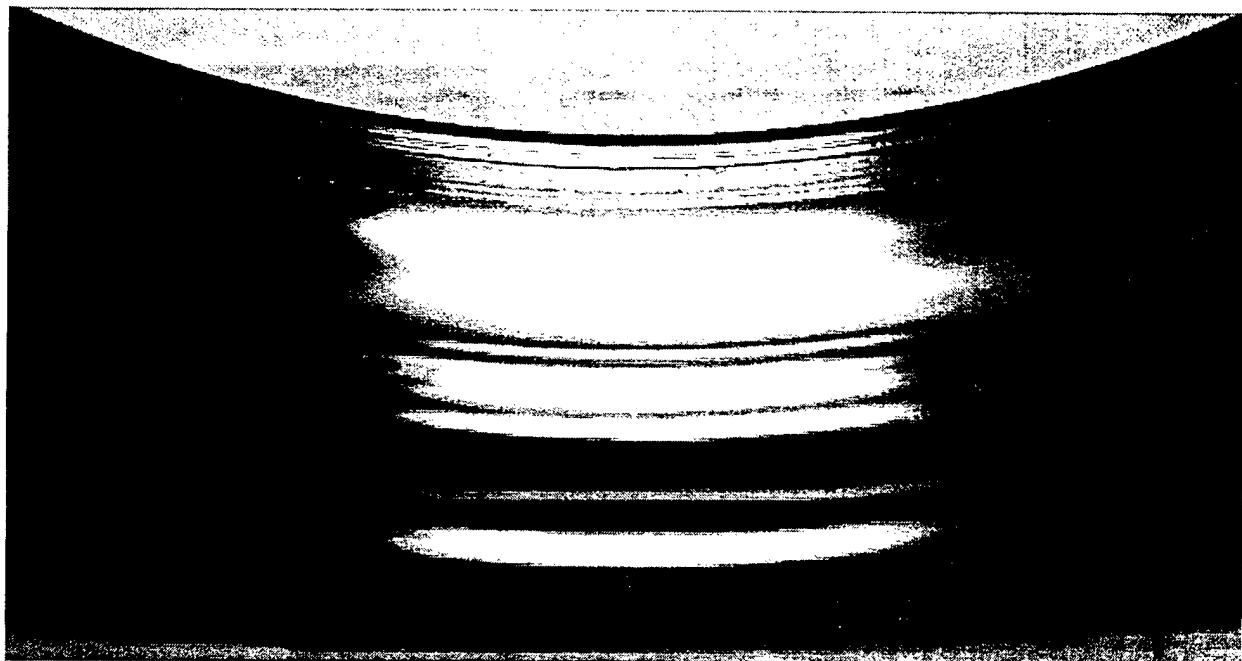
Both bearings had shoulder wear as indicated by the severe wear on the outer race cage guiding shoulders and cage rail outer surfaces. The bearings underwent material evaluation to further examine the microstructure. The wear characteristic of the Pyrowear 675 “hybrid” bearing was deemed unacceptable.

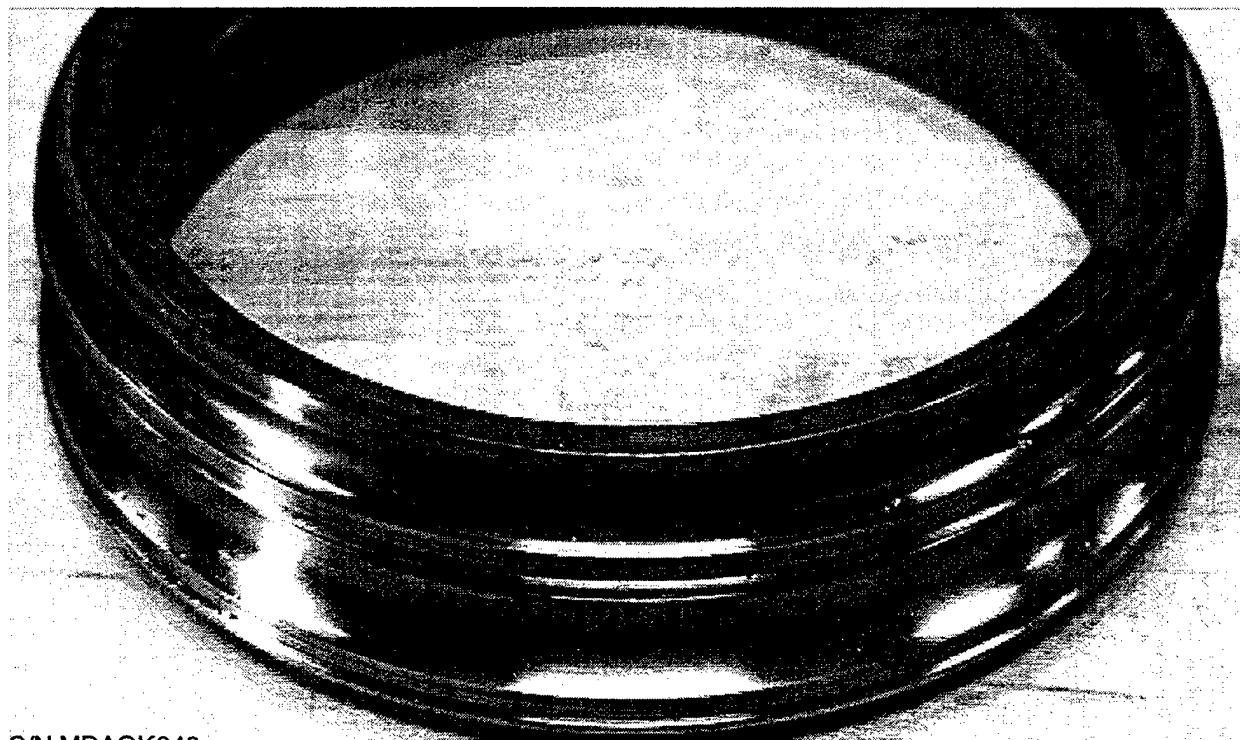
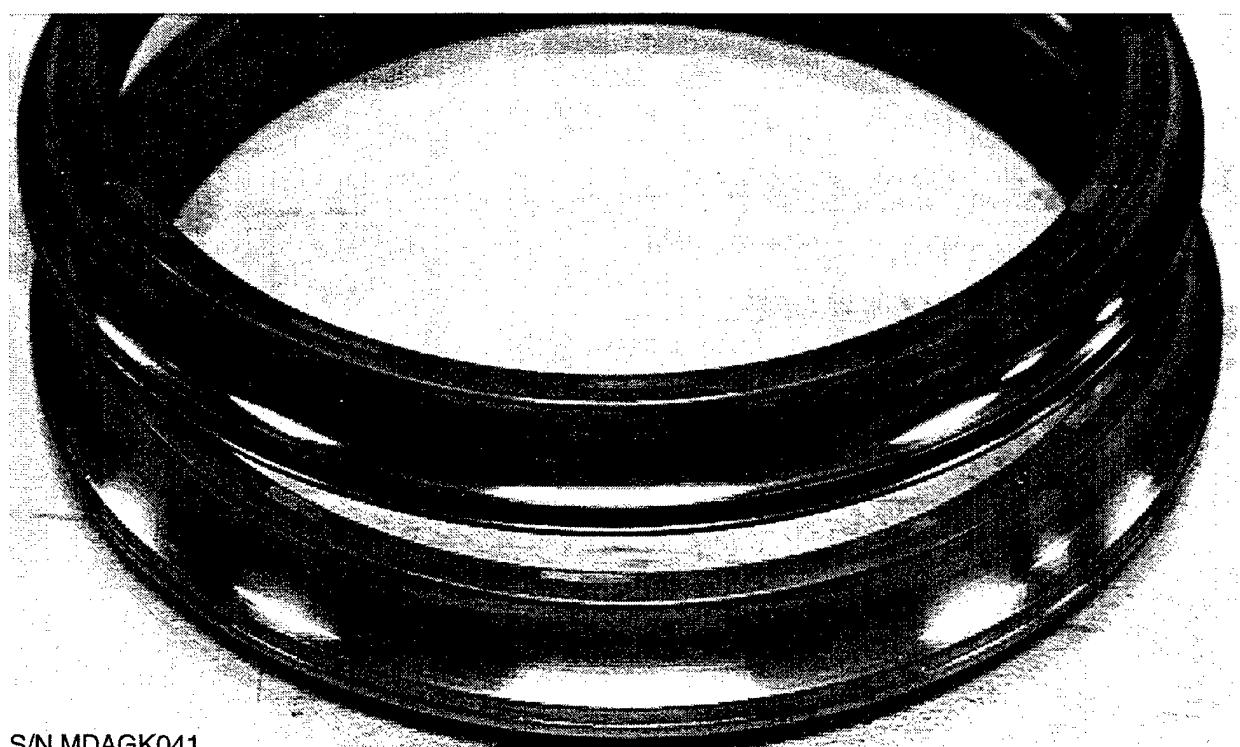
Figure 19. Pyrowear 675 "Hybrid" Outer Race Shoulder Wear

S/N Location	Drawing Required Diameter, in	Posttest Actual Diameter, in	Radial Wear Depth, in
Outer Race Shoulders			
MDAGK040 Forward	7.035 Max.	7.192–7.194	0.0785–0.0795
MDAGK040 Aft		7.196–7.200	0.0805–0.0825
MDAGK041 Forward		7.148–7.157	0.0565–0.0610
MDAGK041 Aft		7.174–7.177	0.0695–0.0710
Inner Race Shoulders			
MDAGK040 Forward	6.241 Min.	6.1832–6.1849	0.0280–0.0289
MDAGK040 Aft		6.1815–6.1859	0.0275–0.0297
MDAGK041 Forward		6.2200–6.2220	0.0095–0.0105
MDAGK041 Aft		6.2170–6.2190	0.0110–0.0120

Further alloy development is warranted to improve the shoulder wear resistance. The impact on bearing endurance, contamination resistance, and corrosion resistance would need assessment.

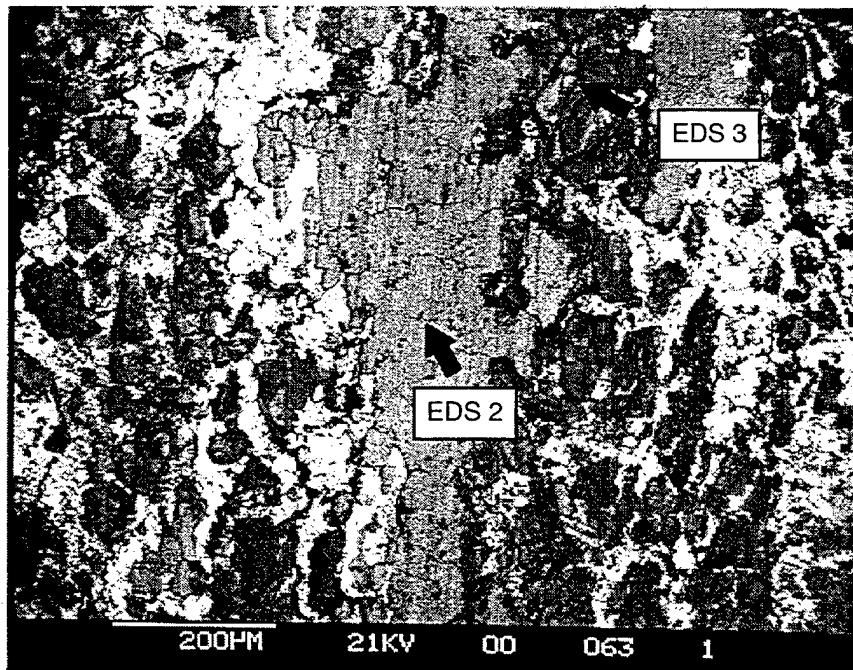
SEM analysis of sections of the bearing cage from a Pyrowear 675 bearing and a Cronidur 30 bearing was done to evaluate the wear products embedded in the silver plating. The energy dispersive spectra analysis of the Pyrowear 675 wear products embedded in the silver plate revealed wear particles of

Pyrowear 675 and mechanically alloyed particles rich in chromium and vanadium (Figures 35 through 39).

Figure 36. SEM Photograph of Bearing Cage Outer Diameter (110X)
Arrows indicate areas of EDS analysis.

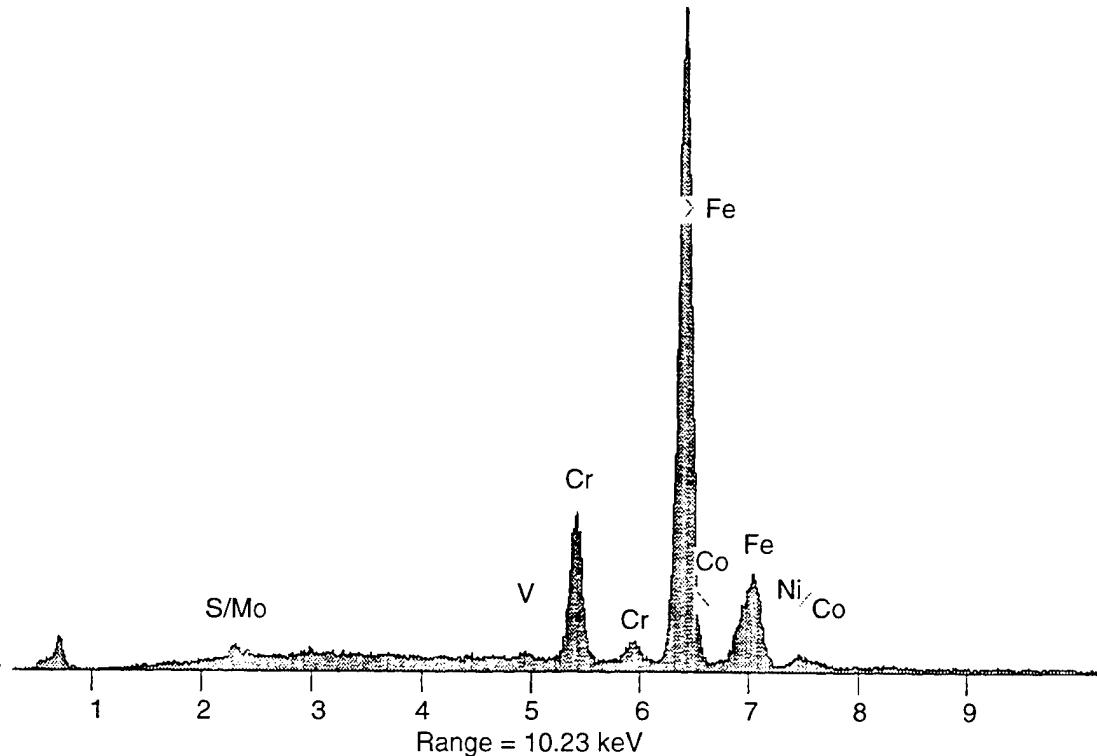
Figure 38. EDS 2 (Fig. 36) Signature Indicating Pyrowear 675 Wear Particles

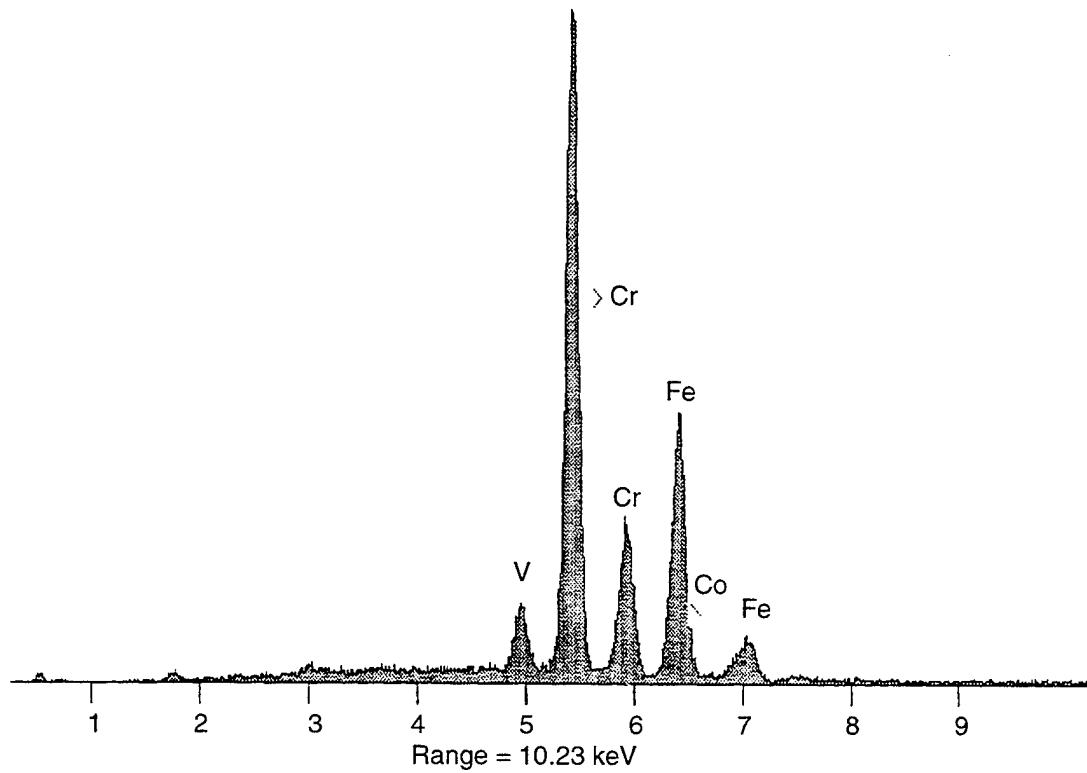
Figure 39. EDS 3 (Fig. 36) Signature Indicating Elevated Chromium and Vanadium in the Wear Product with Reduced Iron Content

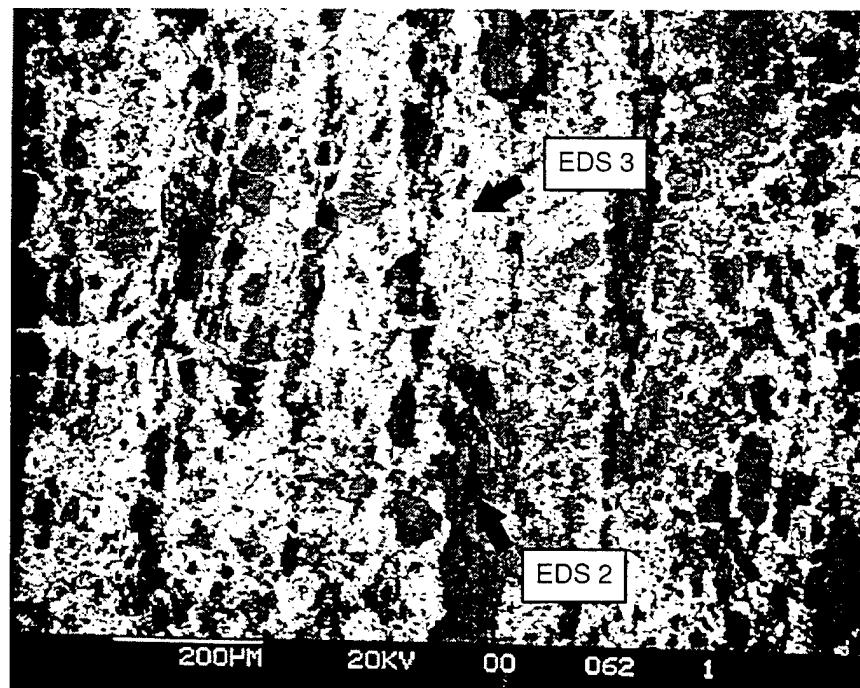
SEM EDS analysis of the Cronidur 30 wear products embedded in the silver plating indicated wear particles of Cronidur 30 and mechanically alloyed particles, rich in chromium and silicon (Figures 40 through 44). These embedded wear products are very similar to those found in cages from shoulder-worn M50NiL bearings — from this same test and from field-service bearings. The M50NiL wear products are high in chromium, vanadium, and silicon (Figures 45 through 47).

Figure 41. SEM Photograph of Bearing 3B Cage Outer Diameter (100X)
Arrows indicate areas of EDS analysis.

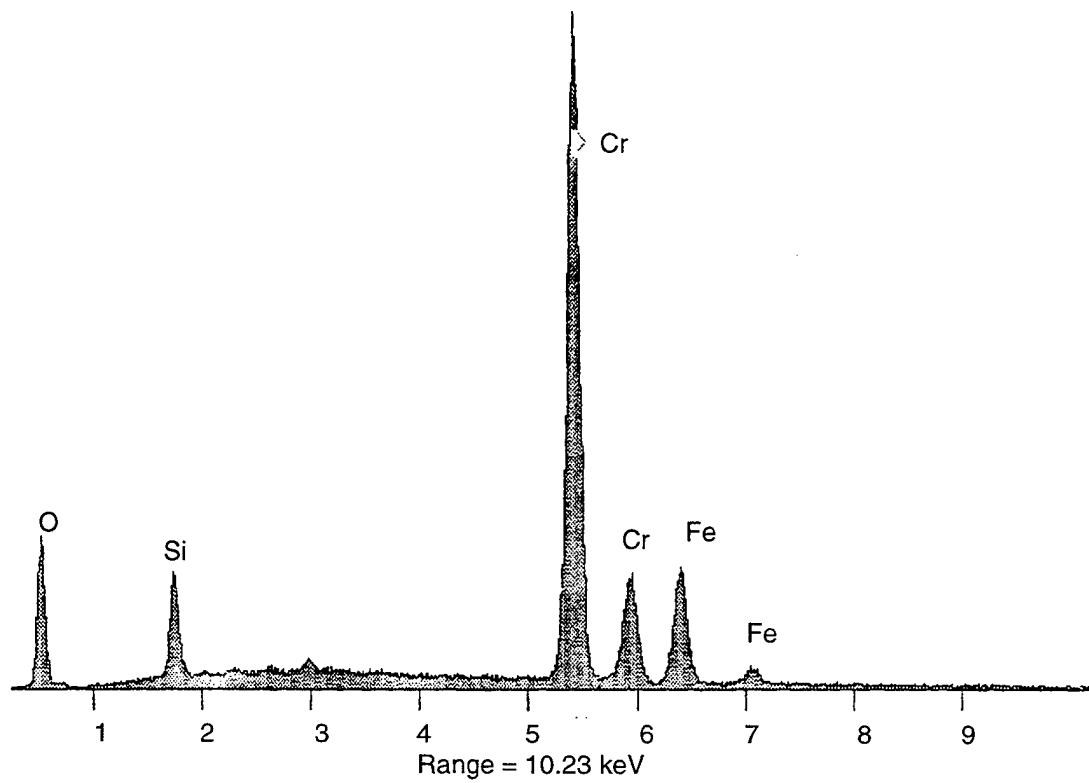
Figure 43. EDS 2 (Fig. 41) Signature Showing Elevated Chromium, Silicon, and Oxygen in the Wear Product

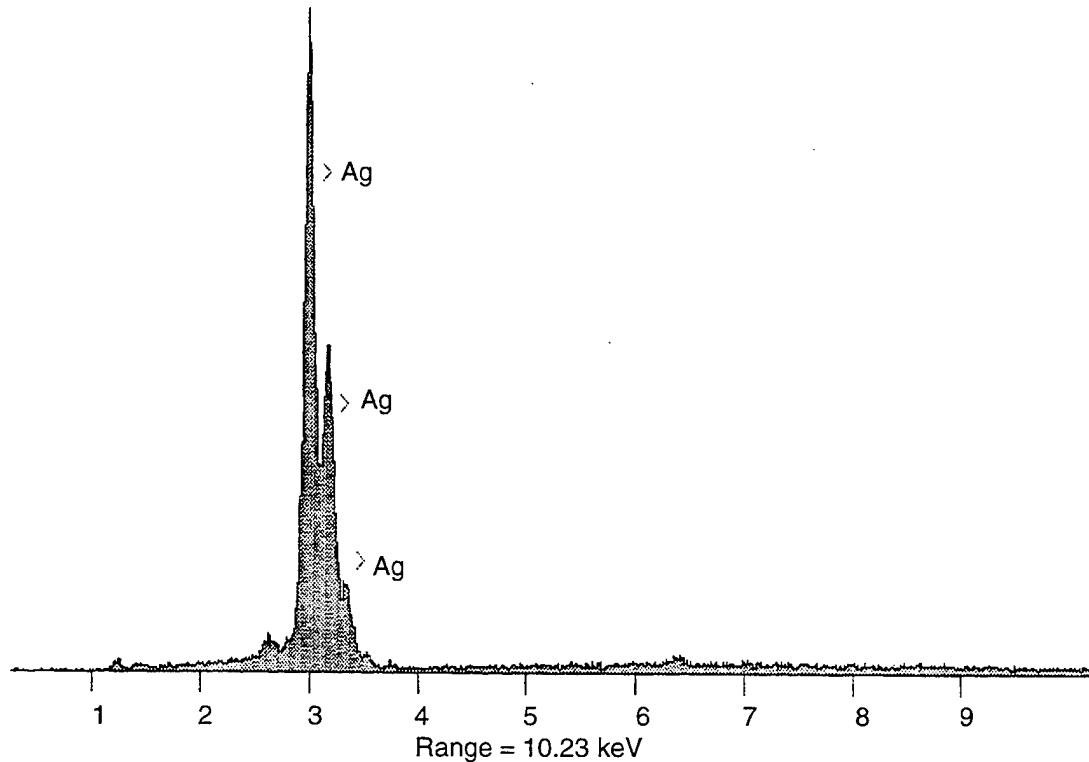
Figure 44. EDS 3 (Fig. 41) Signature Indicates Silver Plating

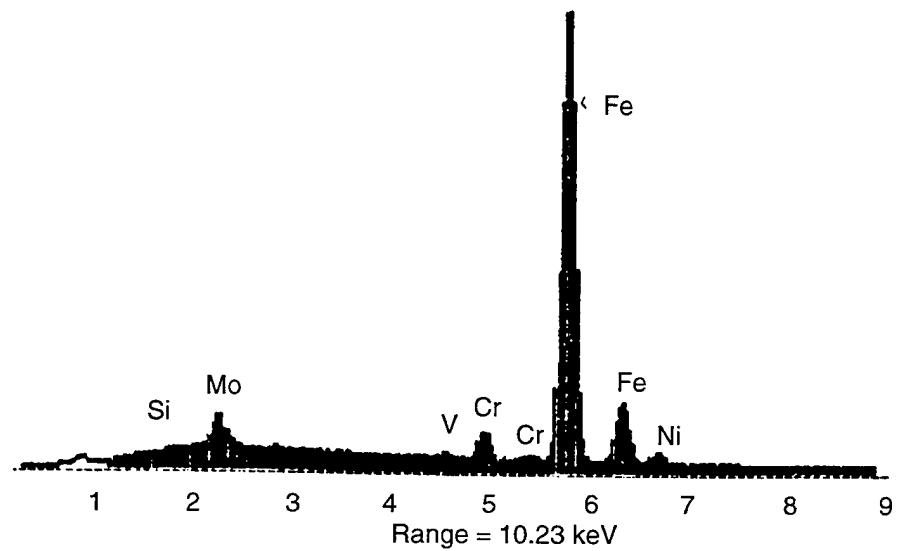
Figure 46. EDS Spectra for Cage Land Wear Products Typical of M50NiL

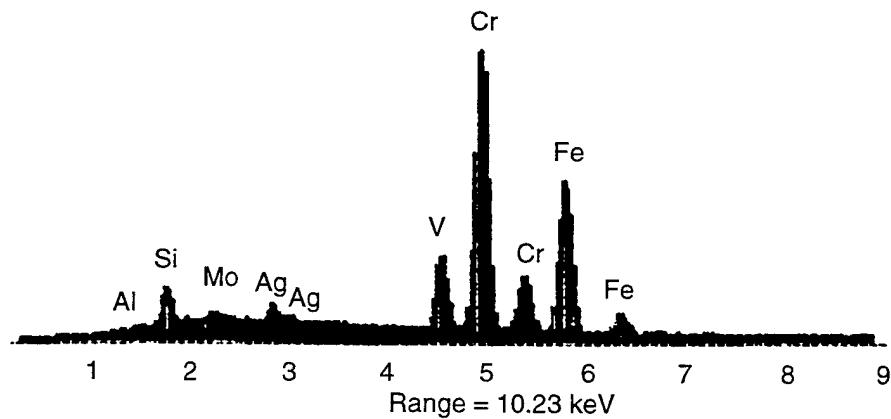
Figure 47. EDS Spectra Showing High Cr, Si, and V Wear Debris

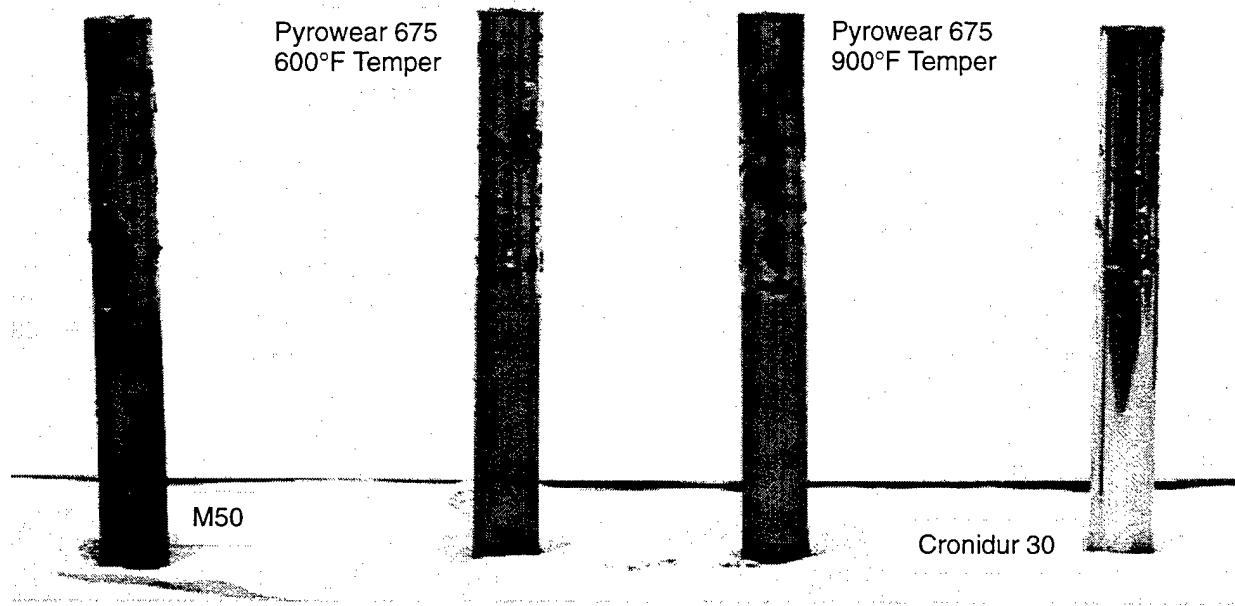
Figure 48. Corrosion Resistance Test: Tap Water

After 23 days of exposure, the M50 specimen was almost covered in corrosion, and the Pyrowear 675 specimens displayed a fair amount of corrosion. The Cronidur 30 material, on the other hand, was showing very little corrosion. The 600°F tempered Pyrowear 675 still exhibited less corrosion than the 900°F tempered Pyrowear 675 specimens in the tap water solution. Figures 48 and 49 show the specimens after 23 days of exposure in tap water and synthetic sea water solutions, respectively.

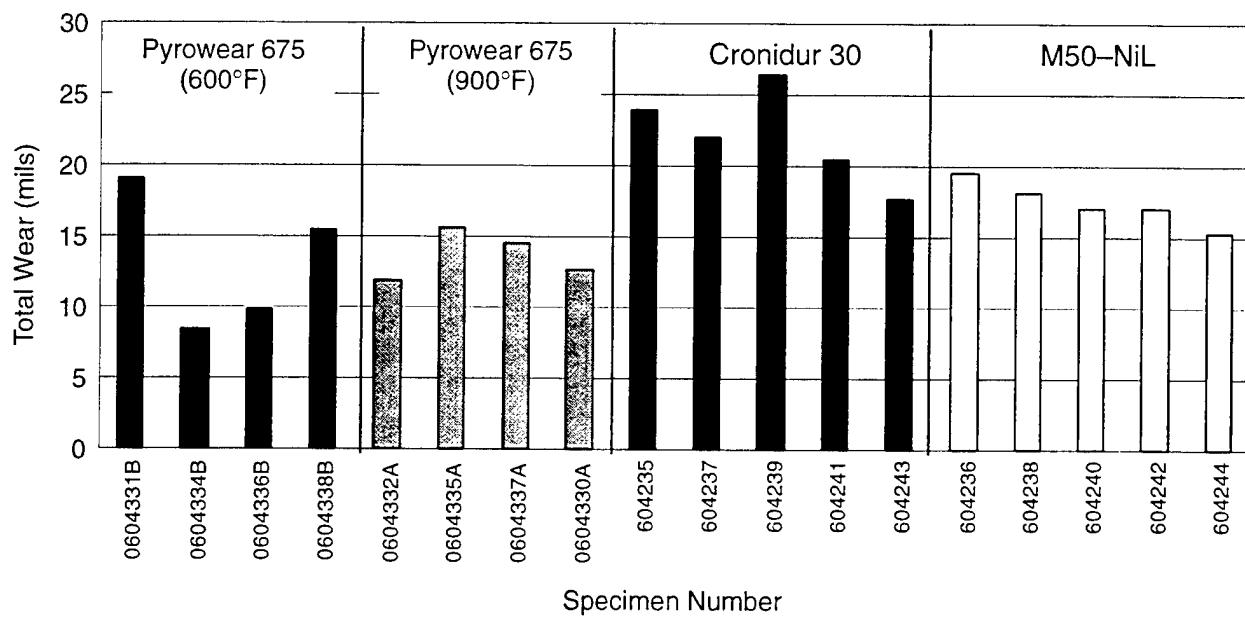
Figure 50. Total Wear from Specimens (Results Reported by Falex Corporation)

Pyrowear 675, on the other hand, appears to offer greater wear resistance than M50NiL, although it does not appear to be as wear resistant as M50. Table 4 and Figures 50 and 51 summarize the results. The total wear of eight segments of M50 material was roughly 9 mils after similar prior testing. Average Pyrowear 675 total wear was on the order of 13.5 mils for both the 600°F tempered and the 900°F tempered specimens. This is not totally surprising since the Pyrowear 675 case material contains carbides that are visible at 200 \times magnification, unlike the Cronidur 30 and M50NiL materials where the carbides are difficult to resolve even at 500 \times magnification. On the other hand, M50 contains large primary carbides from the melting and solidification of the alloy, and large carbides significantly contribute to wear resistance. It is important to note that the rather large spread in Pyrowear 675 wear data may indicate sensitivity to process or microstructural conditions.
